**WATERS ENGINEERING CO.
GENERAL BUILDING INSPECTION REPORT
LA PLATA MINE, LA PLATA, NEW MEXICO**

**Inspection Report
La Plata Mine Buildings
La Plata, N. Mex.**

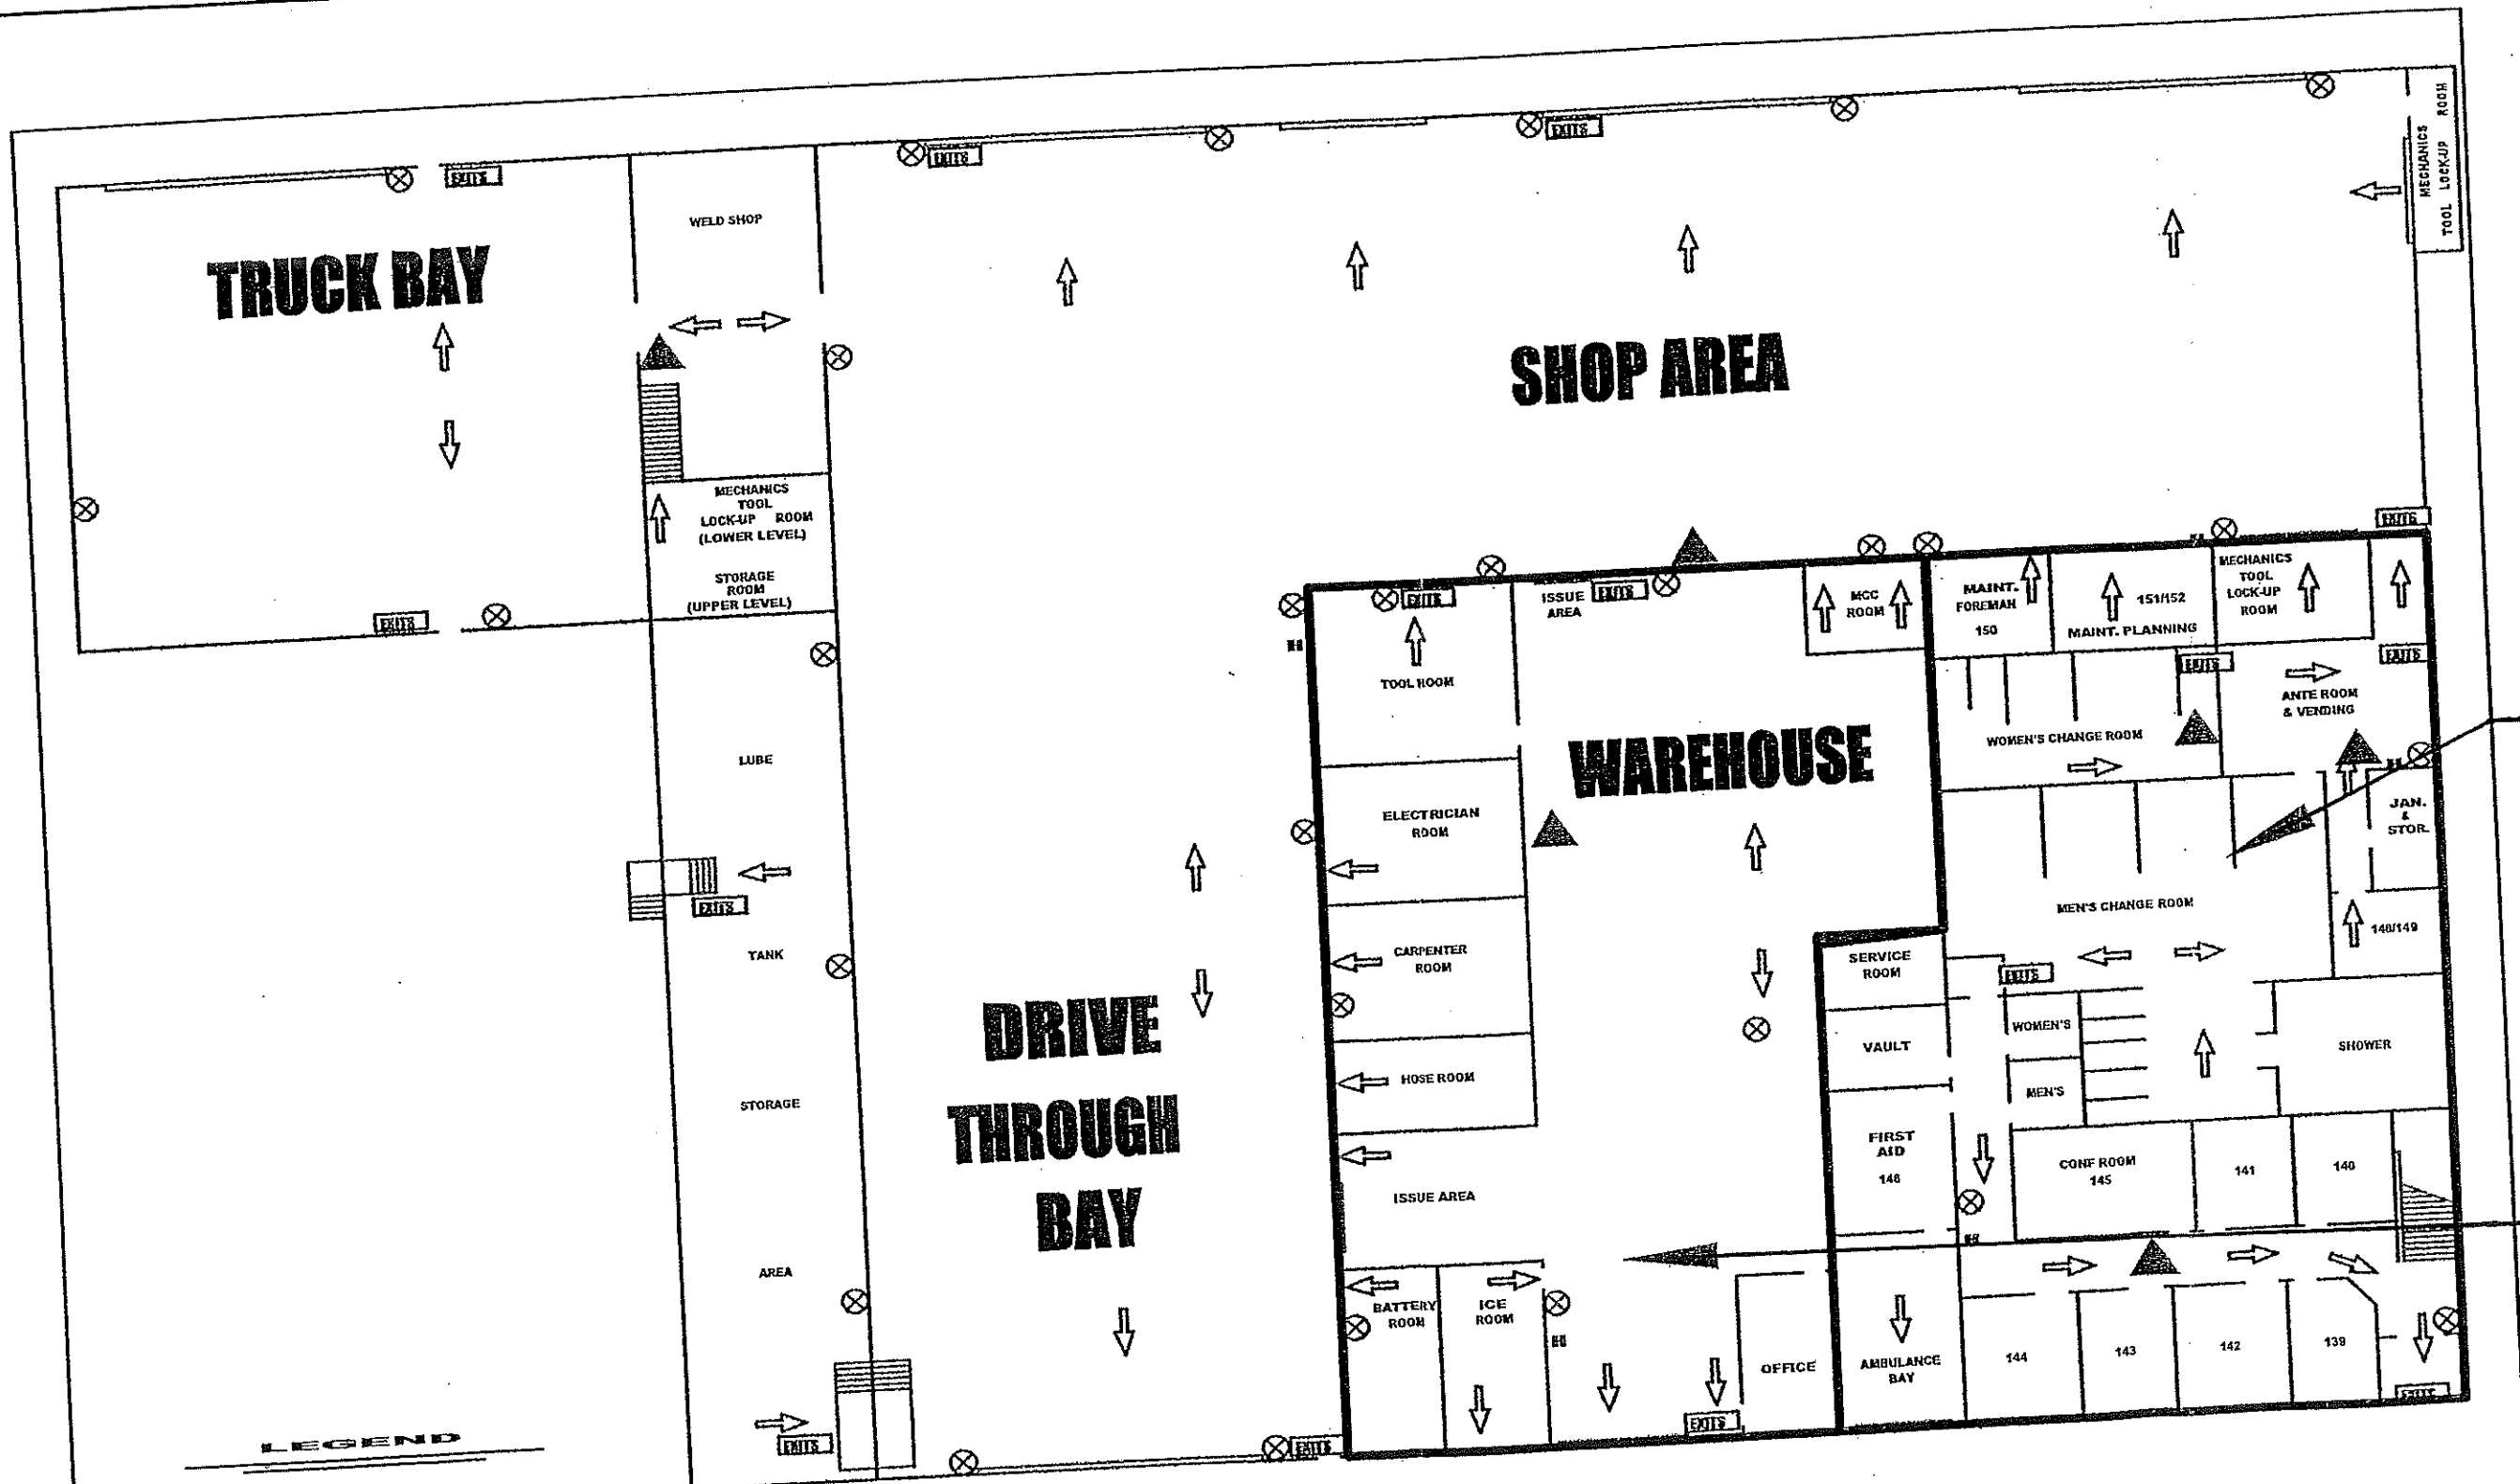
AREA
5798 SQ. FT.

AREA
5545 SQ. FT.

AREA
1441 SQ. FT.

AREA
1246 SQ. FT.

(1) Second floor office	8,623 sq. ft.
(2) Warehouse	8,233 sq. ft.
(3) Lower level change rooms, first aid and support	5,778 sq. ft.
(4) Shop and truck bay	<u>19,283 sq. ft.</u>

(Reference Appendix A Drawings)
