**BID No. 23-24-01 Construction Services for SJC Industrial Park Improvements  
Project**

**ADDENDUM #2  
August 15, 2023**

Re: La Plata Mine Building at La Plata, New Mexico

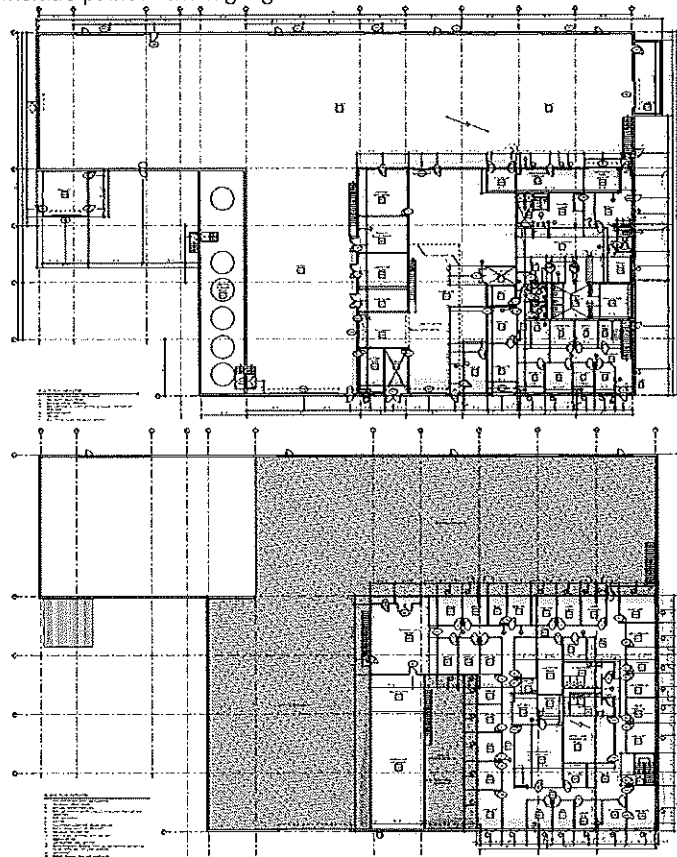
Question 6 From the walk through it seems as if there should be some additional paint scope that is not shown on the plans. Can you please provide a square footage value and if we are matching existing or what the intent is? If we are matching existing there might be the issue with the age of the existing paint and the color variance after time.

Answer 6 Include paint in the highlighted areas
